Composite thermal damage – correlation of short beam shear data with FTIR spectroscopy

Portable, non-destructive analysis

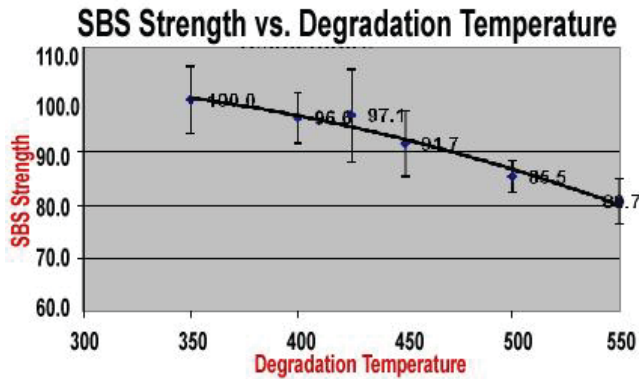
Figure 2. Decreasing SBS strength with increasing temperature

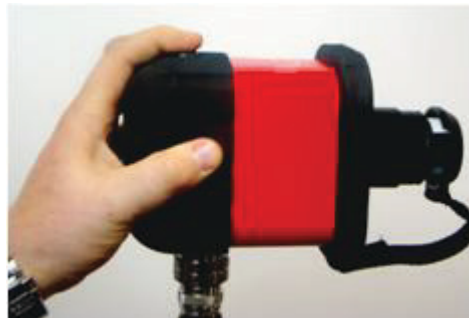
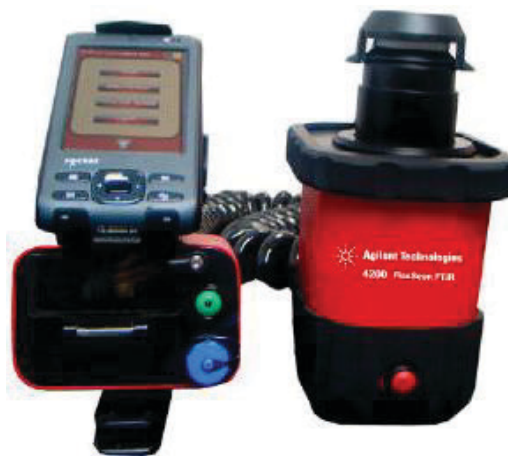
In addition to the 4100 ExoScan FTIR, Agilent offers the 4200 FlexScan FTIR. The 4100 ExoScan and 4200 FlexScan both provide easy, handheld FTIR analysis, but with slightly different form factors. The 4200 FlexScan has the same optical components as the 4100 ExoScan, but the optics and electronics are separated by a cable. This makes the handheld component smaller, while still providing the spectroscopic performance needed for a variety of applications. The 4200 FlexScan has a 3 pound optical head attached to a 4 pound battery and electronics pack. Although the form factor is different, use of the two systems, including the software, is identical. While the 4100 ExoScan provides an integrated, compact package, the 4200 FlexScan has a smaller size to fit into spaces with tight clearances
